**LAKWOOD (EAST) DAM
JACKSON COUNTY, MISSOURI
MO. 20373**

PHASE 1 INSPECTION REPORT NATIONAL DAM SAFETY PROGRAM

PHASE I INSPECTION REPORT

Name of Dam	Lakewood (East) Lake Dam
State Located	Missouri
County Located	Jackson County
Stream	West Fork of May Brook
Date of Inspection	8 August 1978

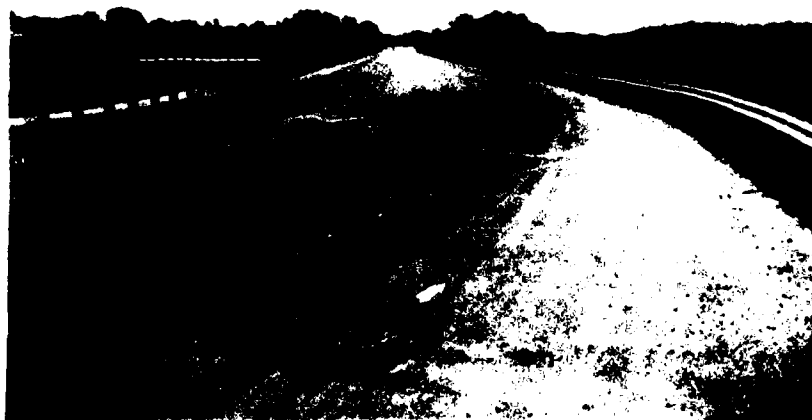
PHOTO NO. 2: TOP OF DAM

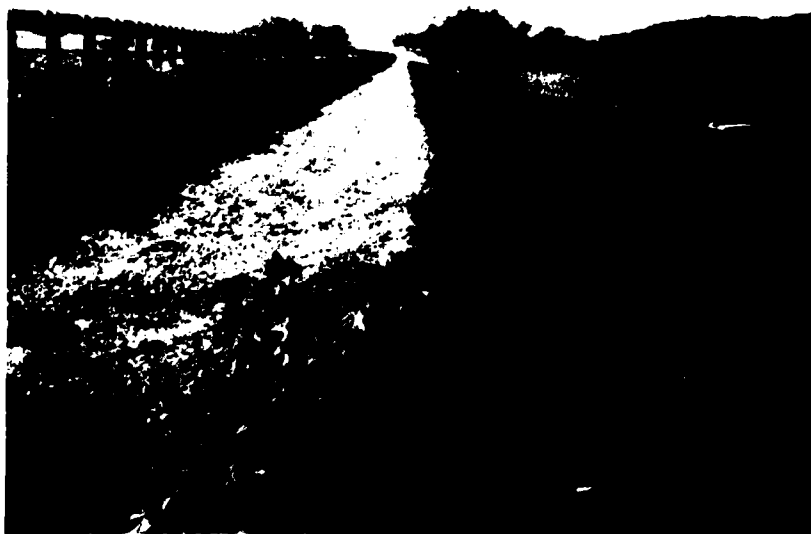
PHOTO NO. 3: LOCATION OF NEWLY PLACED WATER LINE ON
DOWNSTREAM FACE(Looking South)

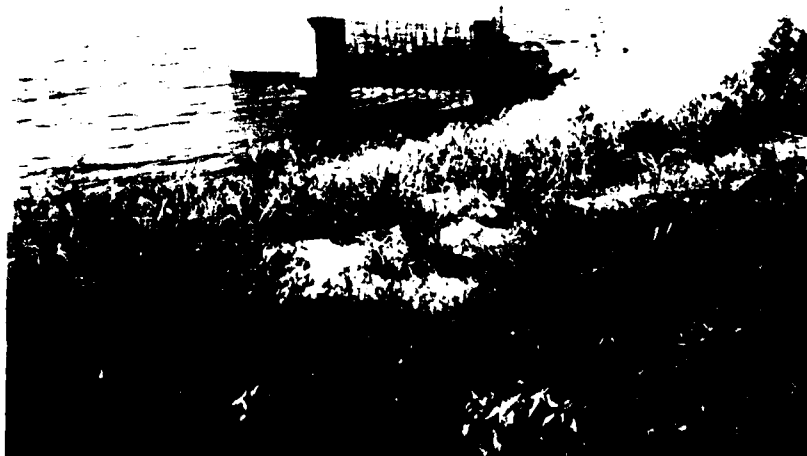
PHOTO NO. 6: UPSTREAM FACE OF DAM AND DROP INLET SPILLWAY
(Looking South)

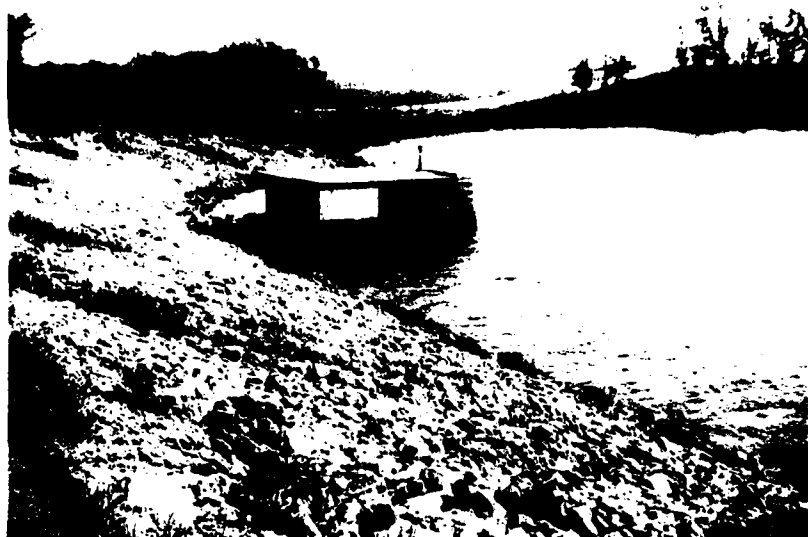
(1) The drop inlet spillway, discharge outlet, and the spillway discharge channel are in good condition. The emergency spillway appears in good condition.

PHOTO NO.. 7: DROP INLET SPILLWAY, EMERGENCY SPILLWAY, AND NORTH ABUTMENT
(Looking North)
